Dutch East India Company Shipbuilding

THE ARCHAEOLOGICAL STUDY OF
BATAVIA AND OTHER SEVENTEENTH-
CENTURY VOC SHIPS

Wendy van Duivenvoorde

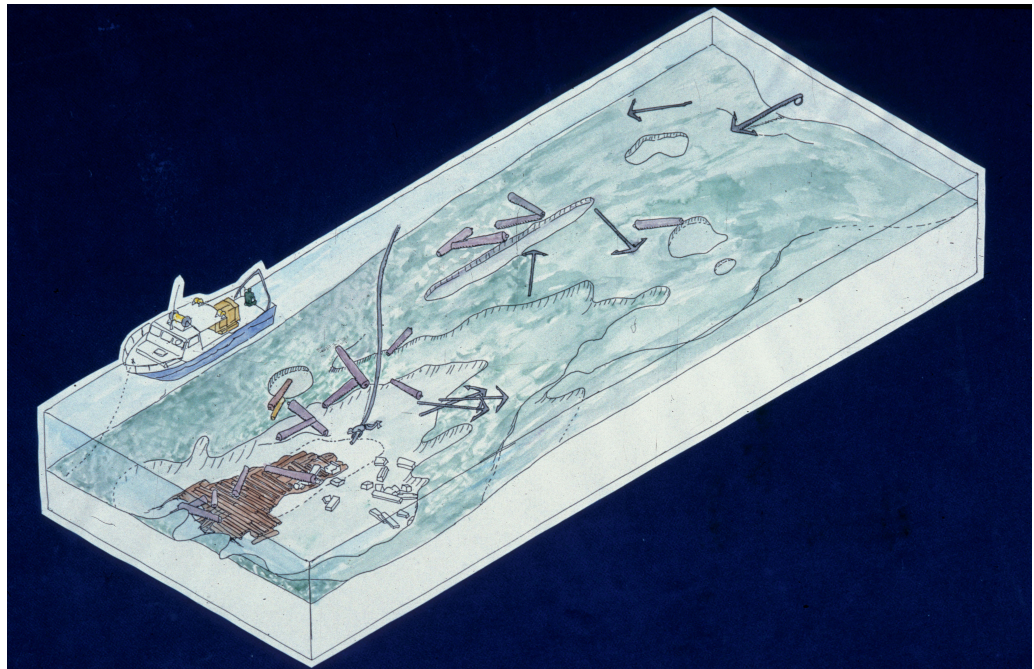
FIGURE 3-3. Isometric view of the *Batavia* shipwreck excavation site. Illustration by Patrick Baker, Western Australian Museum (BT-D-0033).

The Houtman Abrolhos is an archipelago of islands and reefs situated about 60 km off the Western Australian coast. It includes one distinct island and three main island groups: North Island, the Pelsaert Group, also known as the Southern Group, the Easter Group, and the Wallabi Group (fig. 3-1). The remains of the *Batavia* lie at a depth of 3 to 7 m at the southwestern end of Morning Reef in the Wallabi Group. The wreck site covers an area of about 50 m in length and 15 m in width and is oriented in a north-south direction, with the ship's bow at the northern end on top of the reef edge in the shallower part of the site (figs. 3-2 and 3-3).

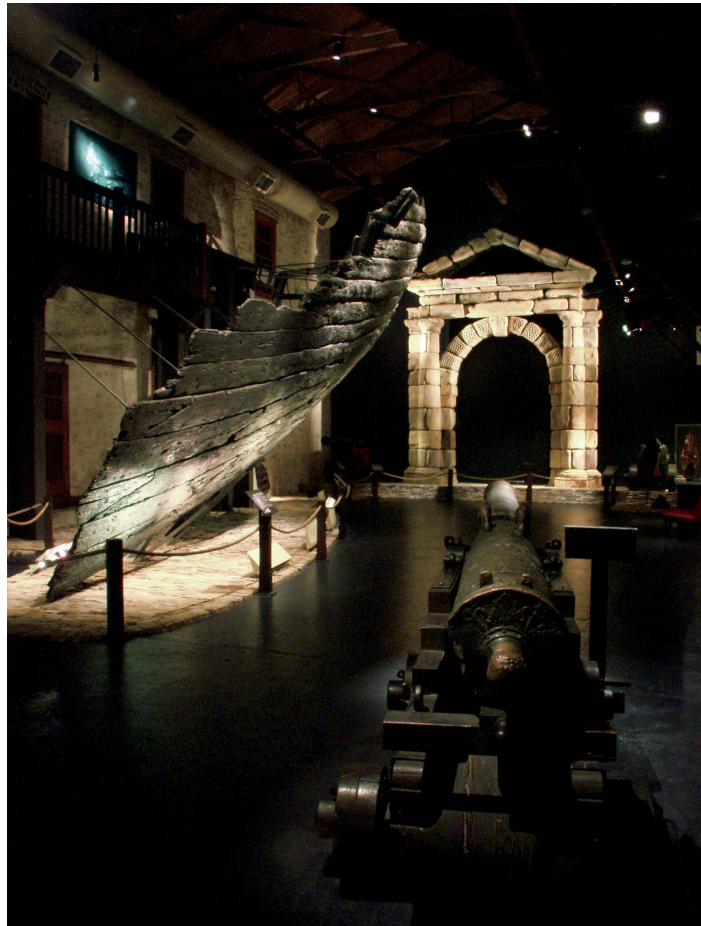
FIGURE 3-4.
Remains of *Batavia* on display in the Western Australian Museum—Shipwreck Galleries, Fremantle. Photograph by author.

A substantial part of the hull has been reassembled and is displayed in the Western Australian Museum—Shipwreck Galleries in Fremantle (fig. 3-4). The structure on display measures 11 m in length, 6.5 m in height, and 4 m in width. Many other timbers still remain in storage at the museum, however. These timbers are separate because they were poorly preserved, their precise location on the hull was not known at the time of reassembly, or they are detached or fragmented (figs. 3-5 through 3-8). The timbers in

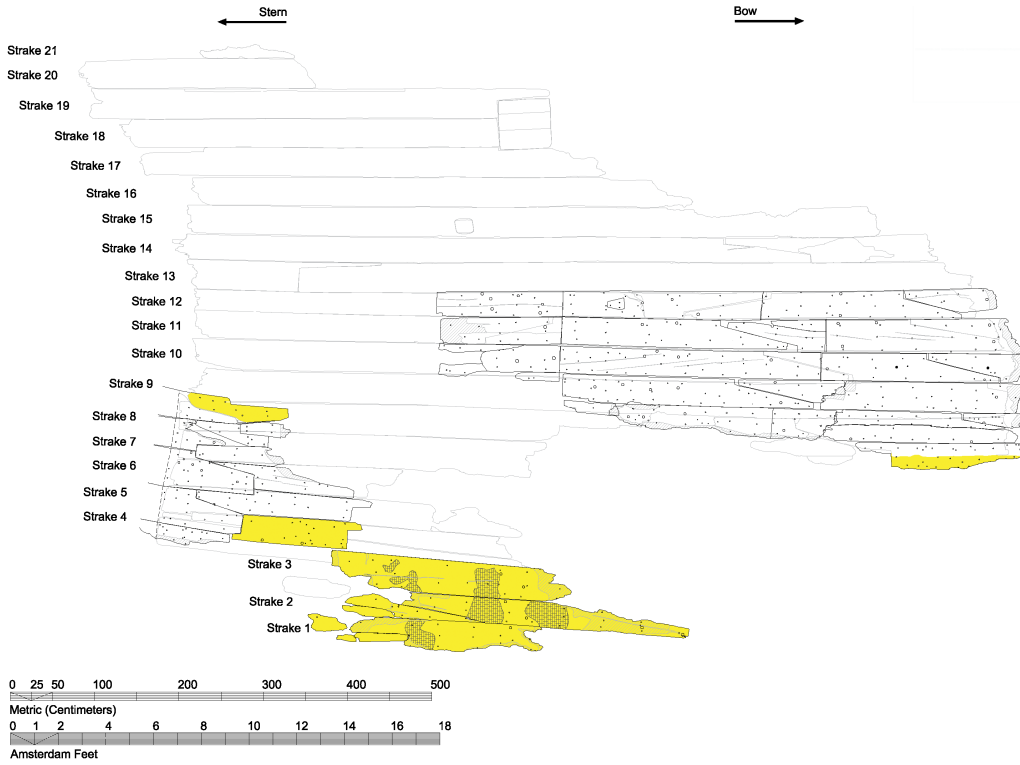
FIGURE 3-5.
Outer layer of *Batavia's* hull planking, port side, interior face. All timbers excluded from display indicated in yellow. Inner layer of hull planking is outlined in gray for orientation. Illustration by author.

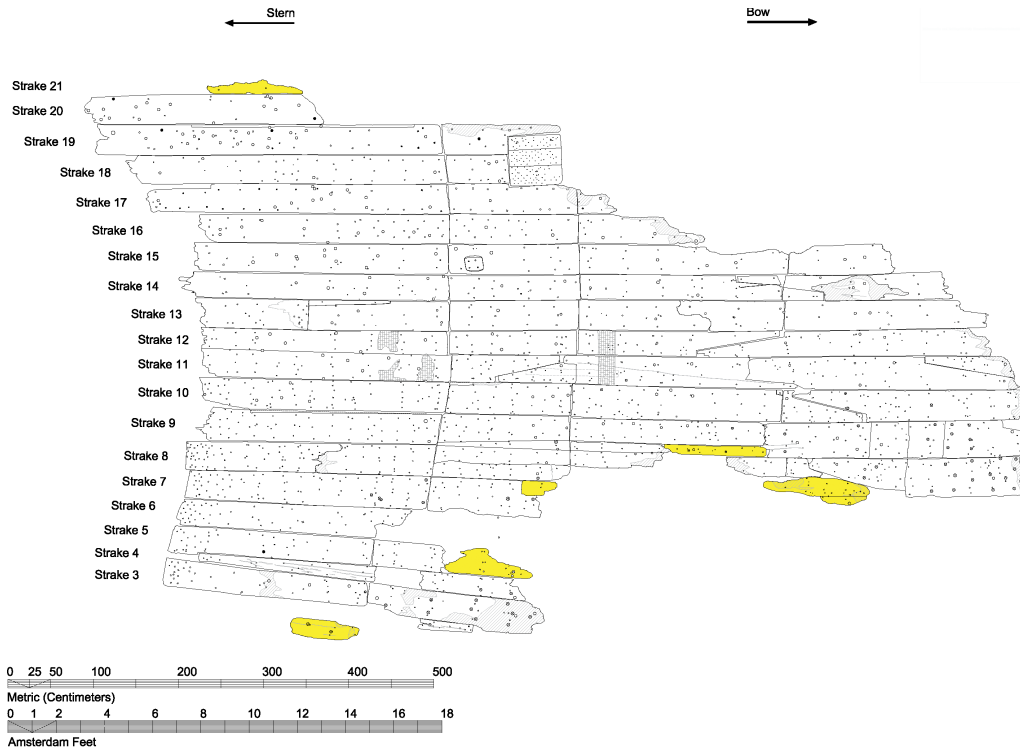
FIGURE 3-6.
Inner layer of *Batavia's* hull planking, port side, interior face. All timbers excluded from display indicated in yellow. Illustration by author.

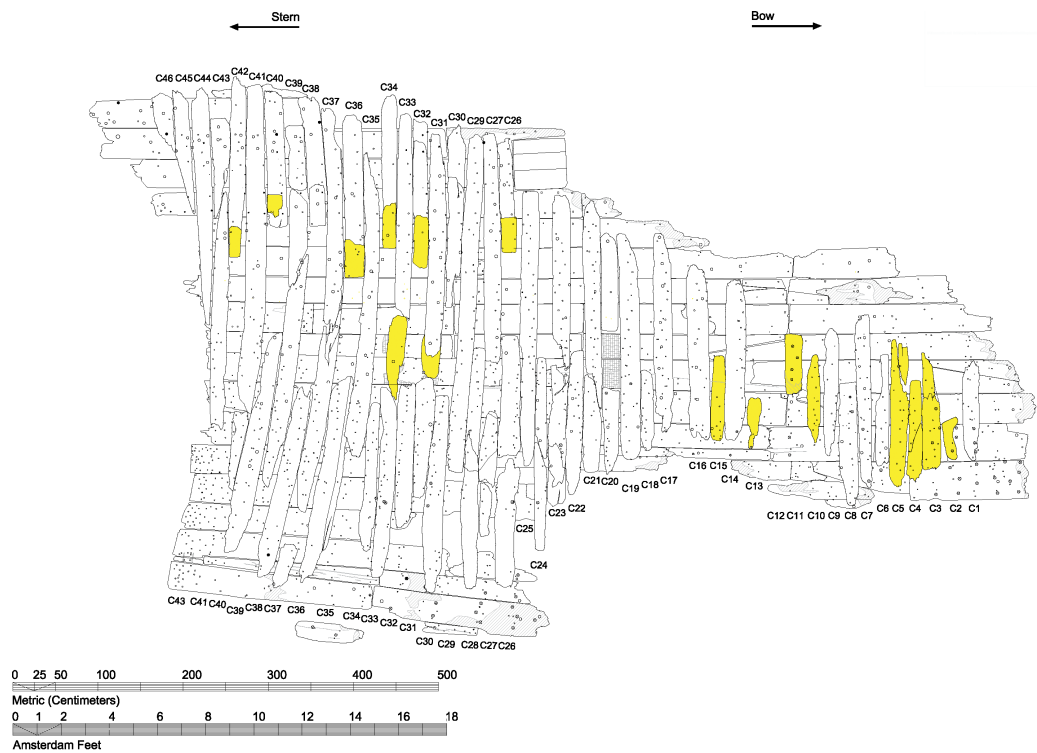
FIGURE 3-7.
Frame timbers of
Batavia's hull, port side,
interior face. All timbers
excluded from display
indicated in yellow.
Illustration by author.

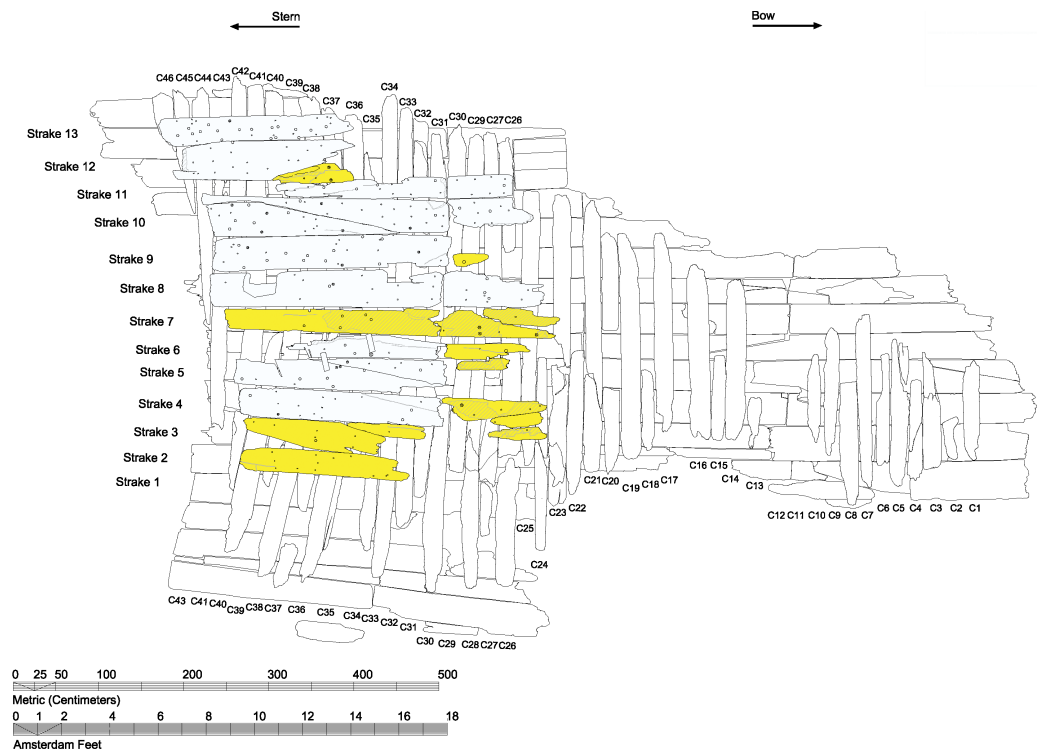
FIGURE 3-8.
Ceiling planking of
Batavia's hull, port side,
interior face. All timbers
excluded from display
indicated in yellow.
Illustration by author.

Twelve stakes of ceiling planking (B1-B7, B9-B13) and one shelf clamp (B8) were raised off the seabed (see fig. 3-8). On top of the ceiling planking (B1-B13), remains of small floor beams or laths have been found that were nailed to the ceiling planking to support a pine inner floor, which protected the ceiling planking. At the junction of *Batavia*'s transoms and the side of the ship, massive lodging knees or transom knees (T-layer)

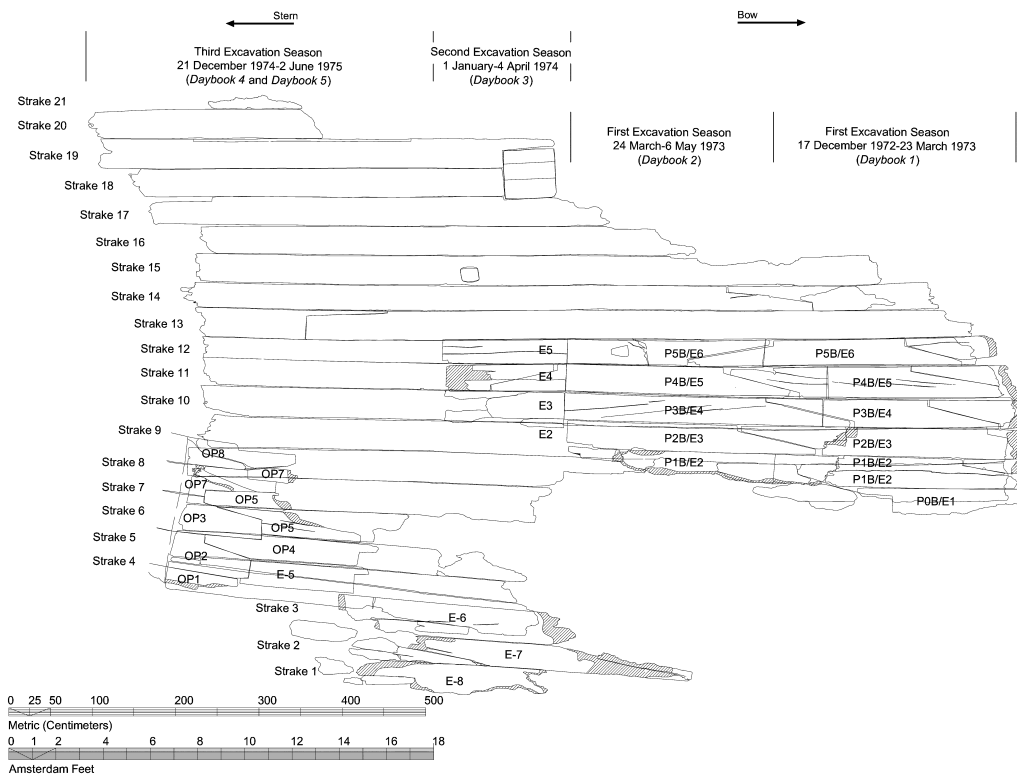
FIGURE 3-9. Field numbers per excavation period for the outer layer of *Batavia*'s hull planking, port side, interior face. Inner layer of hull planking is outlined in gray for orientation. Illustration by author.

The timbers were exposed and raised in sections during the three fieldwork seasons from 17 December 1972 to 8 April 1975.¹⁰ The northernmost section, or forward part of the hull structure, was raised in the first excavation season from 17 December 1972 to 6 May 1973 (figs. 3-9 through 3-11).¹¹ This section is part of the side of the ship's hull and includes remnants of frames, two layers of hull planking, and one or two layers of pine sheathing. During the second season, 1 December 1973 to 4 April 1974, the middle section of hull structure was raised, which included a gun port.¹² No pine sheathing has been preserved from this segment. In the third and last excavation season from 21 December 1974 to 8 April 1975, the aftermost section of the stern was excavated. In addition to another section of the ship's side, the transom timbers and sternpost were raised.¹³ This section also includes the few remains of the lower or main deck of the ship. Pine sheathing was mainly preserved on the transom planking of the ship. The outer layer of hull planking in this section is poorly preserved and probably worn down due to the abrasion of the ship chafing against the seabed before settling firmly into the sediment. This wear and tear of the timbers is most apparent on the exterior corner where the hull planking meets the transom (fig. 3-12).

This method was not applied consistently throughout the three seasons of excavation, as timber prefixes and strake numbers assigned to the forward end do not correspond to the strake number designations of the hull and the ceiling planking in the after end of the preserved hull section (see figs. 3-9 through 3-11). This discrepancy initially caused confusion during study of the hull remains.

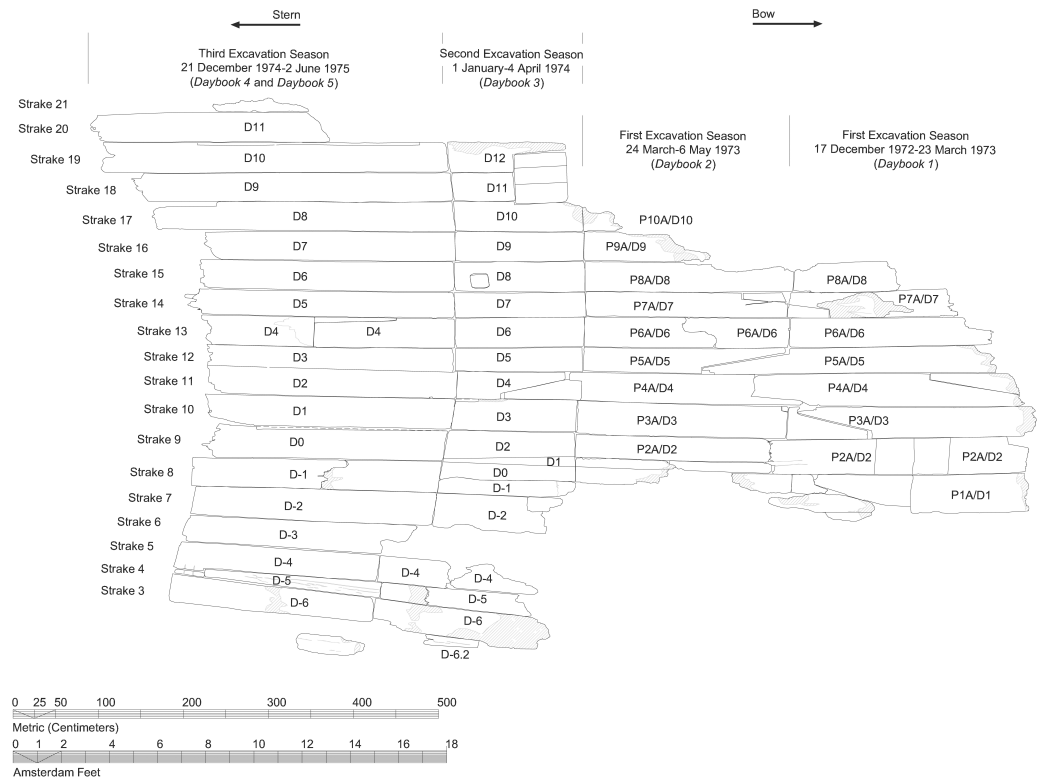
FIGURE 3-10.

Field numbers per excavation period for the inner layer of *Batavia*'s hull planking, port side, interior face. Illustration by author.

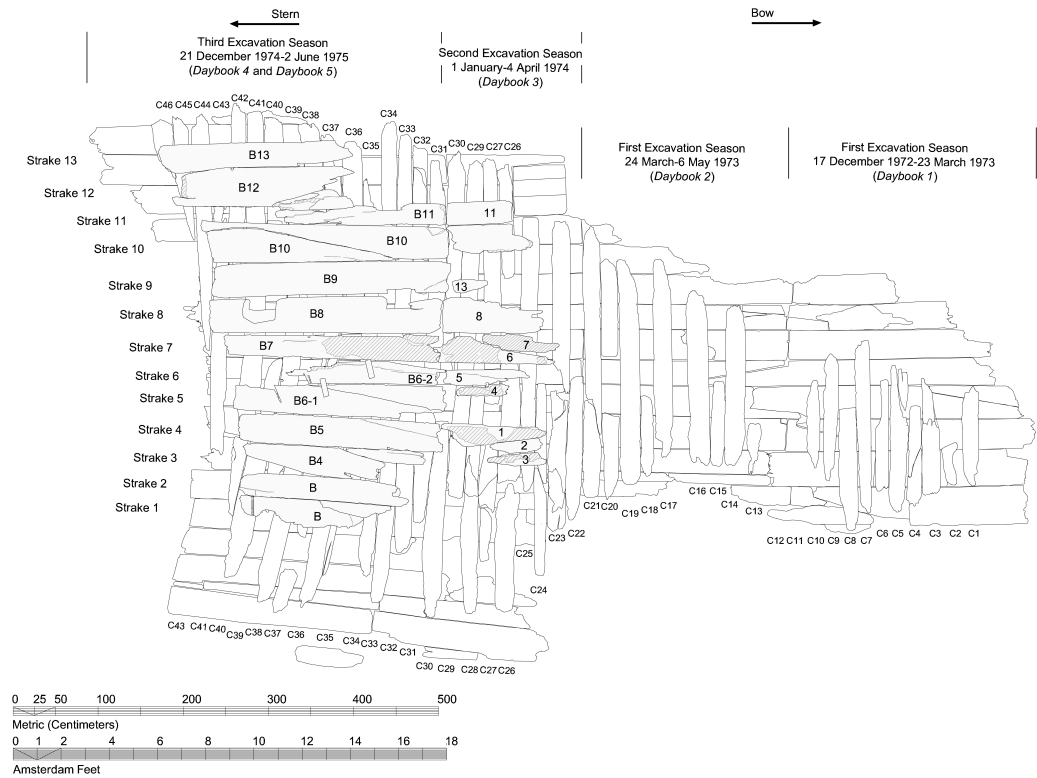
FIGURE 3-11.

Field numbers per excavation period for the ceiling planking and frames of *Batavia*'s hull, port side, interior face. Illustration by author.

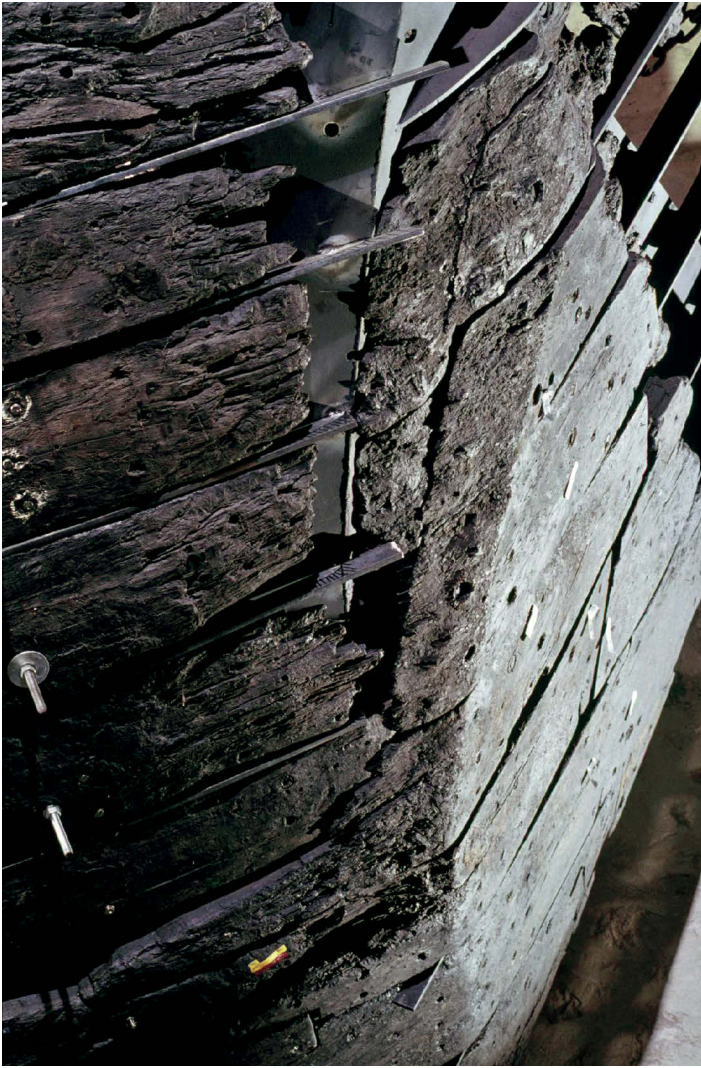
FIGURE 3-12.

Corner of *Batavia*'s side and transom showing erosion of the timbers. Photograph by Patrick Baker, Western Australian Museum (BT-T-0455).

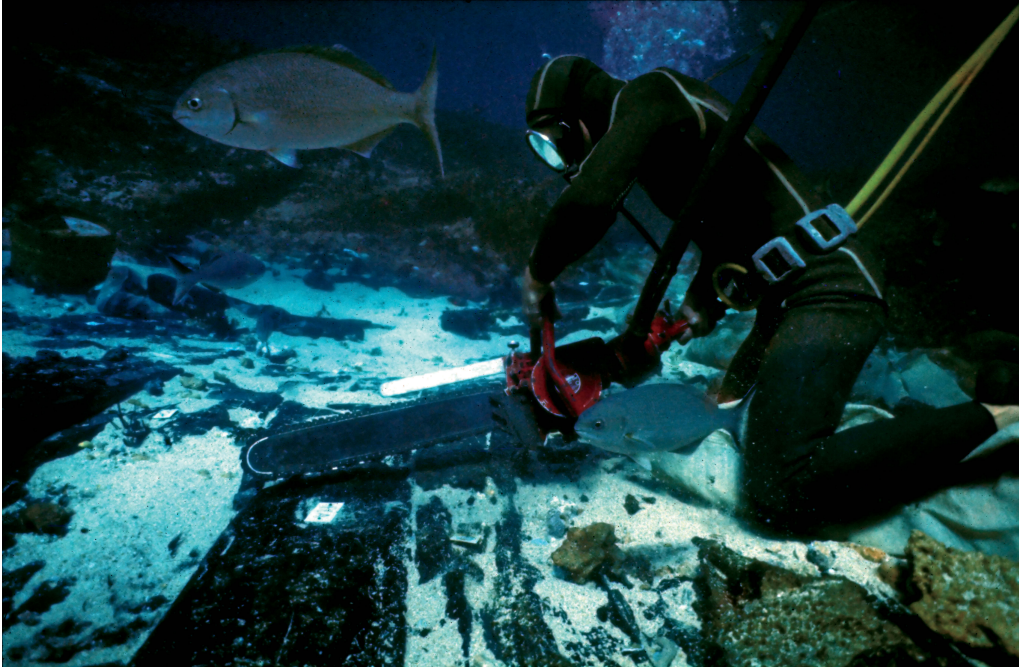
FIGURE 3-13.
Diver sawing *Batavia*'s
hull planking with a
pneumatic chainsaw
during the first
excavation season.
Photograph by Jeremy
Green, Western
Australian Museum
(BT-A-0223).

After being recorded in situ, the timbers were lifted from, or sawn off, the intact hull structure and raised from the seabed (figs. 3-13 and 3-14). The transom knees and hull and ceiling planking were sawn underwater with a pneumatic chainsaw. The sections, measuring approximately 2.97, 2.41, 1.70, and 3.91 m in width from bow to stern—north to south—were easier to handle in hazardous conditions and presented less of a storage problem at the temporary holding area on Beacon Island (see figs. 3-9 through 3-11). It was the most obvious solution for many logistical problems at the time of excavation. The long planking strakes could not have been recovered in their entirety due to the site's excavation in sections. This excavation method made it unfeasible to raise the 10 m timbers, as they continued underneath the sections that still needed to be exposed. In retrospect, the raising of complete hull timbers may have facilitated a more accurate reconstruction. After the reassembly of the timbers in the Shipwreck Galleries, the saw cuts in the planking strakes remain visible even though they have been concealed as much as possible. The adhesive used to repair broken timbers was 75% (w/v) polyvinylpyrrolidone (PVP) in ethanol, and the filling solution for covering the saw cuts was 90% PEG 3350/10% PVP in ethanol (w/w).¹⁸

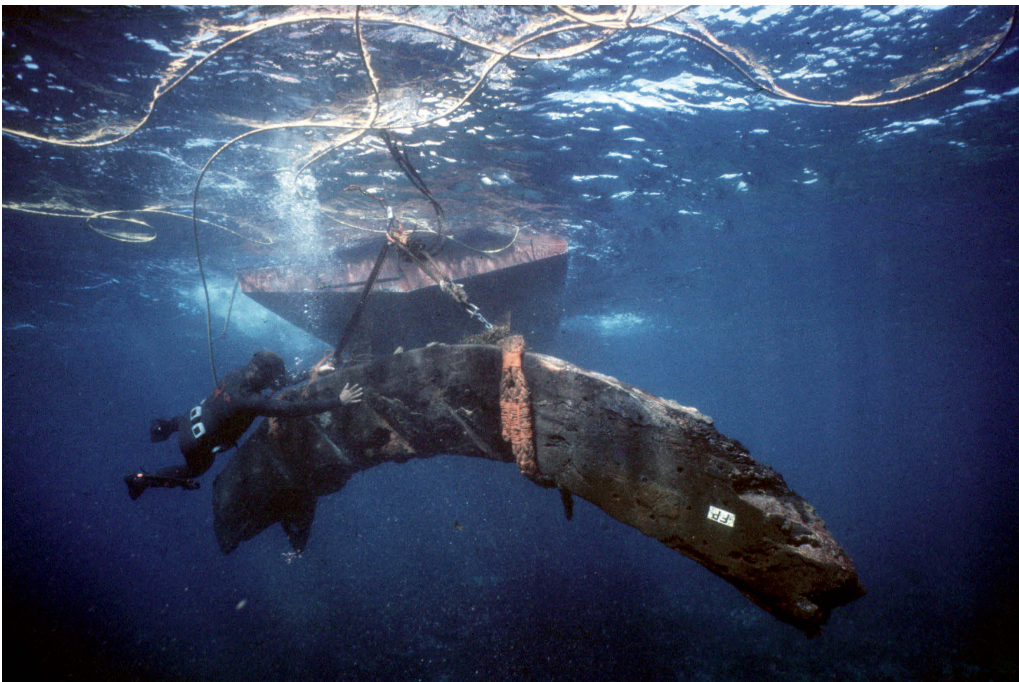
FIGURE 3-14.
Batavia's fashion
piece being raised
with a winch on
the excavation boat
Henrietta during
the third excavation
season. Photograph by
Patrick Baker, Western
Australian Museum
(BT-A-0840).

and not sawn in easily manageable sections. The fashion piece is the single largest timber raised intact from the seabed, measuring 4.6 m in length, 60 cm in width, and 32 cm in thickness.

After the timbers were loosened from the hull structure, they were placed in a sling of nylon rope encased in canvas. The sling was then attached to a steel cable from the excavation boat's winch, and the timbers were lifted aboard the vessel and brought to the excavation camp on Beacon Island (see fig. 3-14).

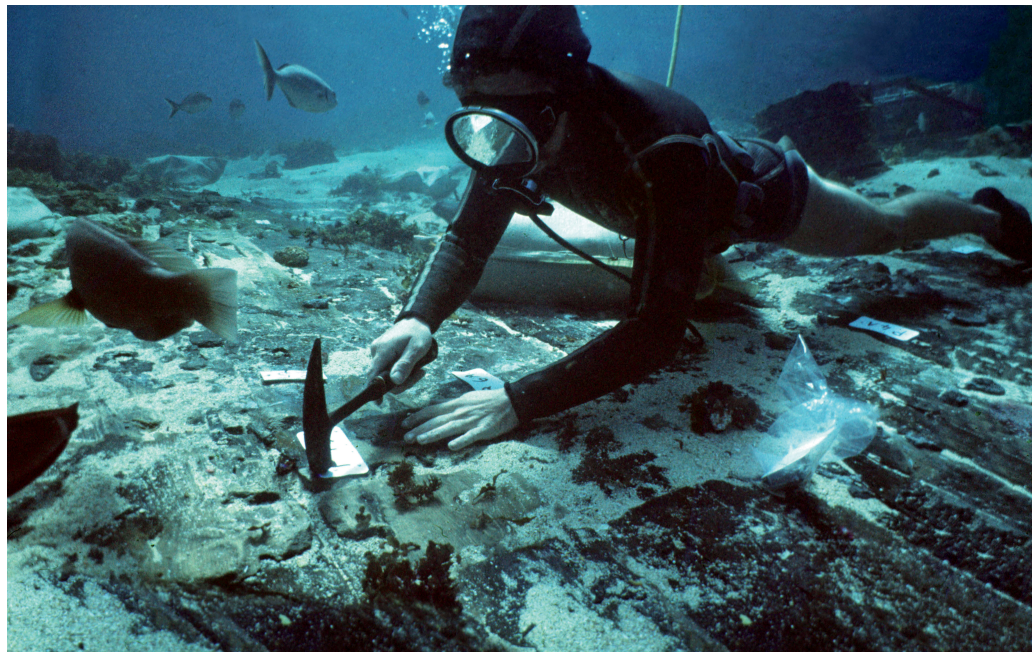
FIGURE 3-15.
Diver attaching an
identification tag
with field number P7A
onto *Batavia*'s inner
layer of hull planking,
strake 14, during
the first excavation
season. Photograph by
Patrick Baker, Western
Australian Museum
(BT-A-0215).

Each individual timber was tagged in situ on the seabed with a PVC label denoting the timber's temporary field number (fig. 3-15). This number was written on the tag with a waterproof permanent marker pen and consisted of an alphabetical prefix followed by a number. The prefix designated the type of timber, such as frame or hull plank, and the number for each timber was consecutive within the types of timber identified on the seabed. The alphabetical prefix related to the basic layers within the ship's hull structure from its interior to its exterior as viewed on the wreck site. The alphabetical prefixes for the timbers' field numbers are listed in table 3-1.

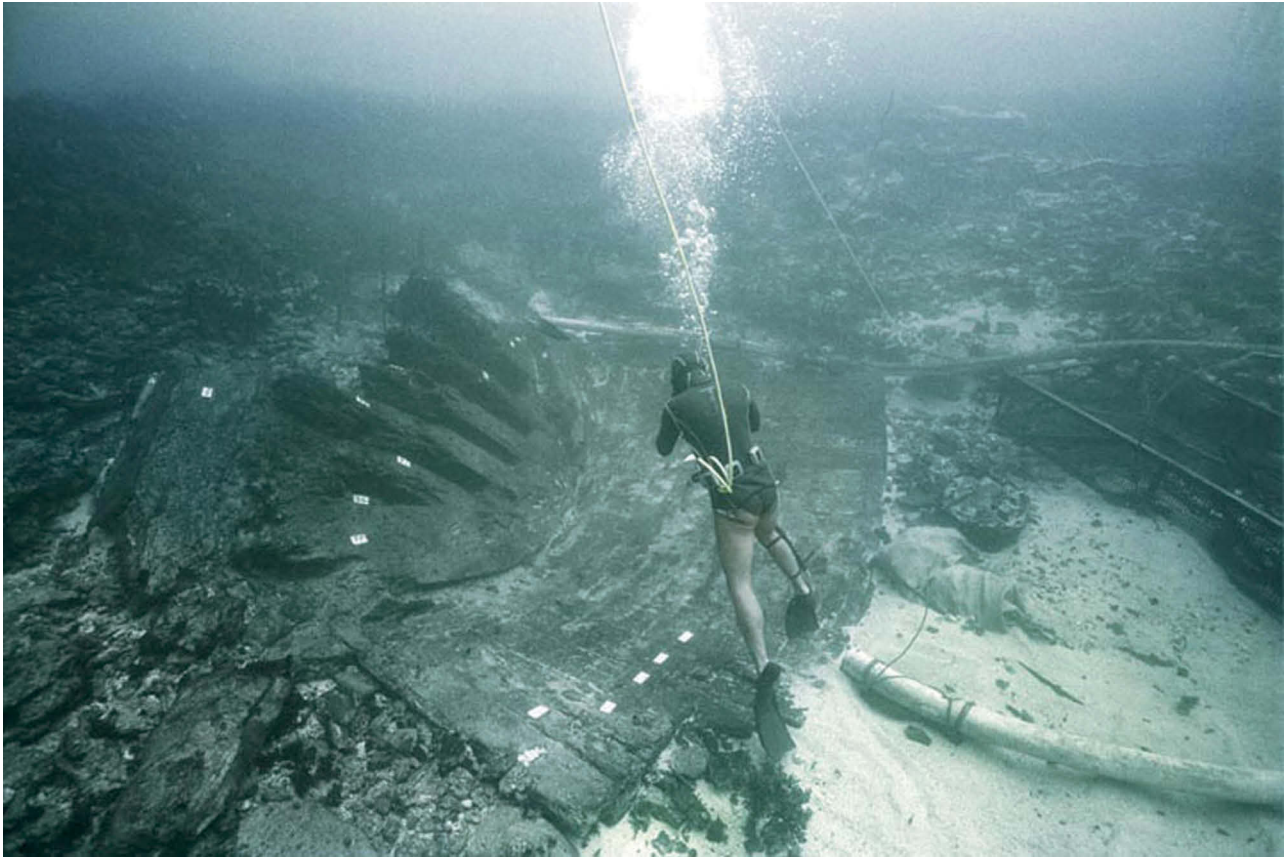
FIGURE 3-16. *Batavia* hull structure, showing inner layer of hull planking and transom timbers, during the third excavation season. Photograph by Patrick Baker, Western Australian Museum (BT-A-0074).

As each area was excavated, the hull structure was cleared of coral sand and coral rubble with an airlift, and the fully exposed area was then photographed. Both standard and stereo photography were used to photograph the hull at each stage of excavation. A Nikonos camera was used, with several water-corrected lenses for different circumstances. For all photogrammetry, either a 28 mm UW Nikkor or a 15 mm lens was used. Two ultra wide-angle lenses, a 15 mm UW Nikkor and a 19 mm Canon, were employed for record and illustrative photography, whereas the first lens was specifically used for overall views of the ship's stern. The entire timber area could be photographed in one frame at a distance of 4 m (fig. 3-16).

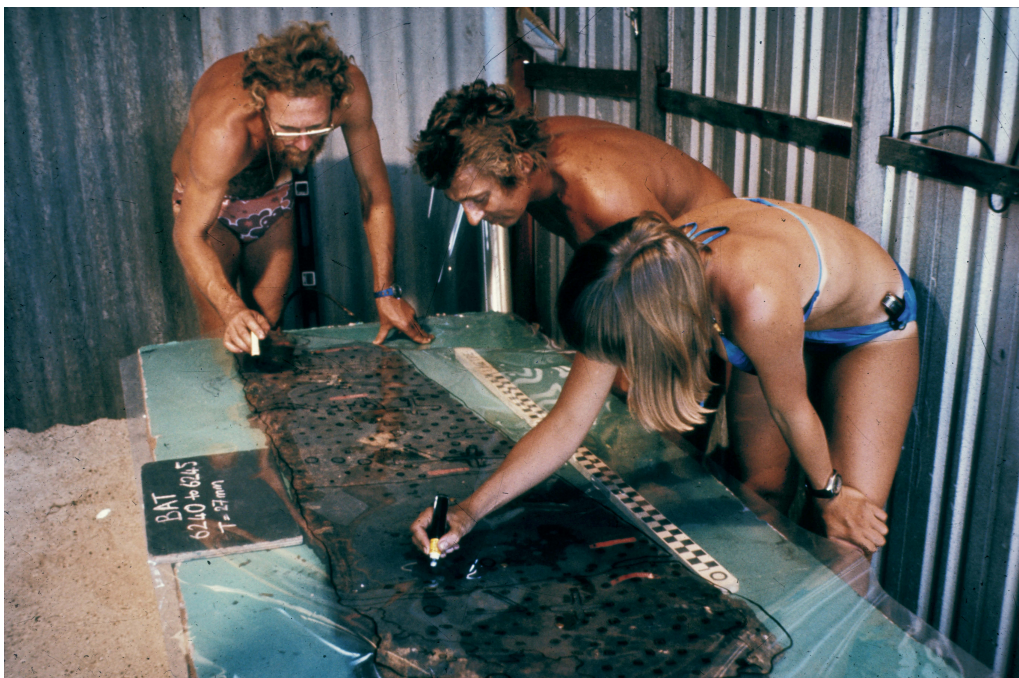
FIGURE 3-17. Tracing pine sheathing of *Batavia*'s sternpost on Beacon Island during the third excavation season. Photograph by Lloyd Capps, Western Australian Museum (BT-B-0696).

The timbers were then partially cleaned in the excavation camp to remove most of their concretions, and full-size drawings were made by tracing them on plastic film with permanent-marker pens (fig. 3-17). This plastic film was applied directly over the timbers, which caused many difficulties. The material occasionally caused condensation to form, which obscured the drawing surface. In addition, the plastic film easily shifted, resulting in measurement errors, and failed to provide a straight surface for accuracy in tracings. Moreover, the polyethylene film used in drawing these timbers shrank, due to its anisotropic nature, within six years in an irregular fashion because of temperature changes.²²

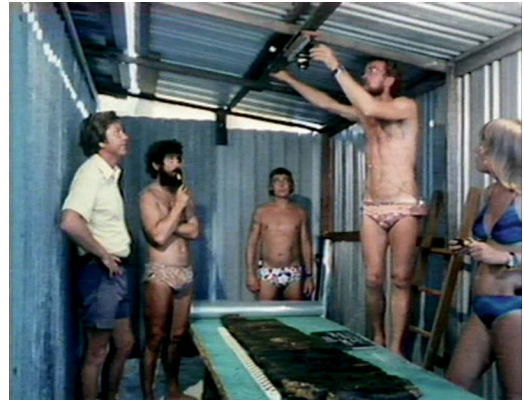
FIGURE 3-18.

Photography setup for timber recording on Beacon Island during third excavation season. Photograph by ABC Peach's Australia, *The Unlucky Voyage*, 1990, Western Australian Museum.

In addition to being traced, each individual timber was photographed in an open-ended shed on Beacon Island, which provided suitable shade from direct sunlight. A 35 mm Nikon F camera was placed 2 m above the ground on a roof beam and focused with a right-angle view finder (figs. 3-18 and 3-19). Timbers were wheeled into the shed on a flat-bed trolley and placed directly below the camera. The camera was mounted so that the film plane was exactly horizontal, and timbers were then leveled using a builder's spirit level.²³ Special care was taken to ensure this parallel relationship between the timber surface and the plane of the camera in order to reduce distortion.

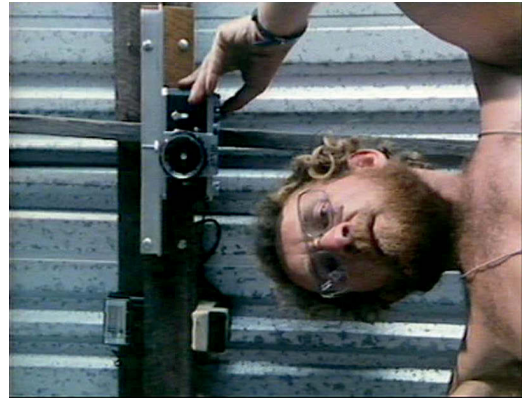
FIGURE 3-19.

Patrick Baker photographing *Batavia's* timbers with a 35 mm Nikon F camera mounted onto a roof beam of a shed on Beacon Island during third excavation season. Photograph by ABC Peach's Australia, *The Unlucky Voyage*, 1990, Western Australian Museum.

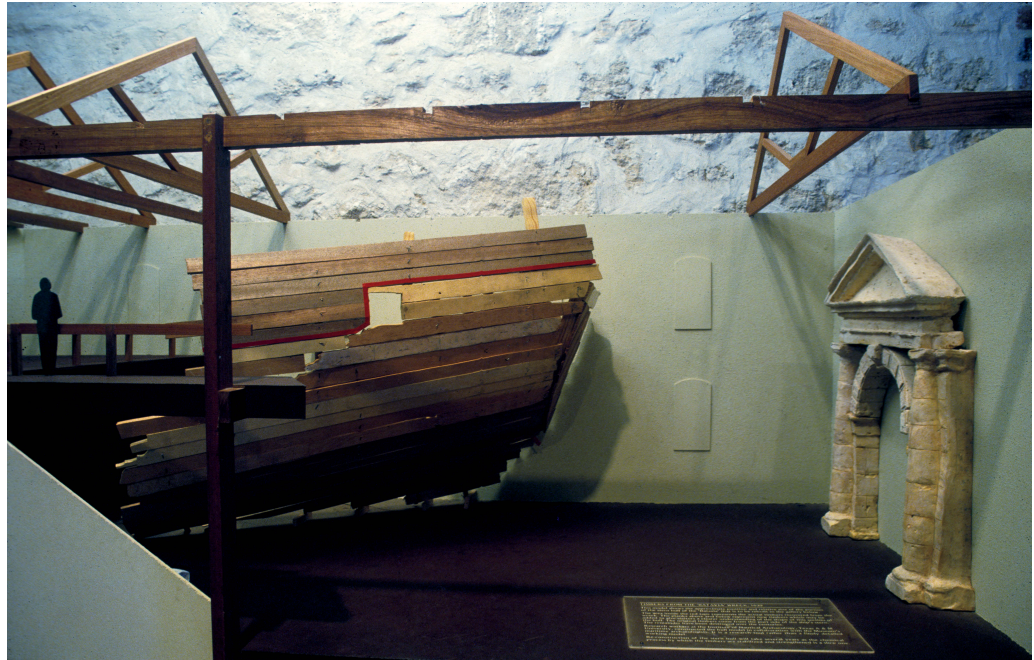
FIGURE 3-20.
Scale model (1:10) of the
initial design for the
reassembly of *Batavia*'s
hull. Photograph by
Patrick Baker, Western
Australian Museum
(BT-T-0164).

hull remains at a scale of 1:10, after which Nick Burningham worked on a full model of the ship's reconstruction on the same scale (figs. 3-20 and 3-21). The first model was based mainly on the photomosaics of *Batavia*'s hull structure prior to excavation and the photographs taken of the timbers on the seabed and after being raised.²⁹ Due to lack of funding, the second model still awaits completion.

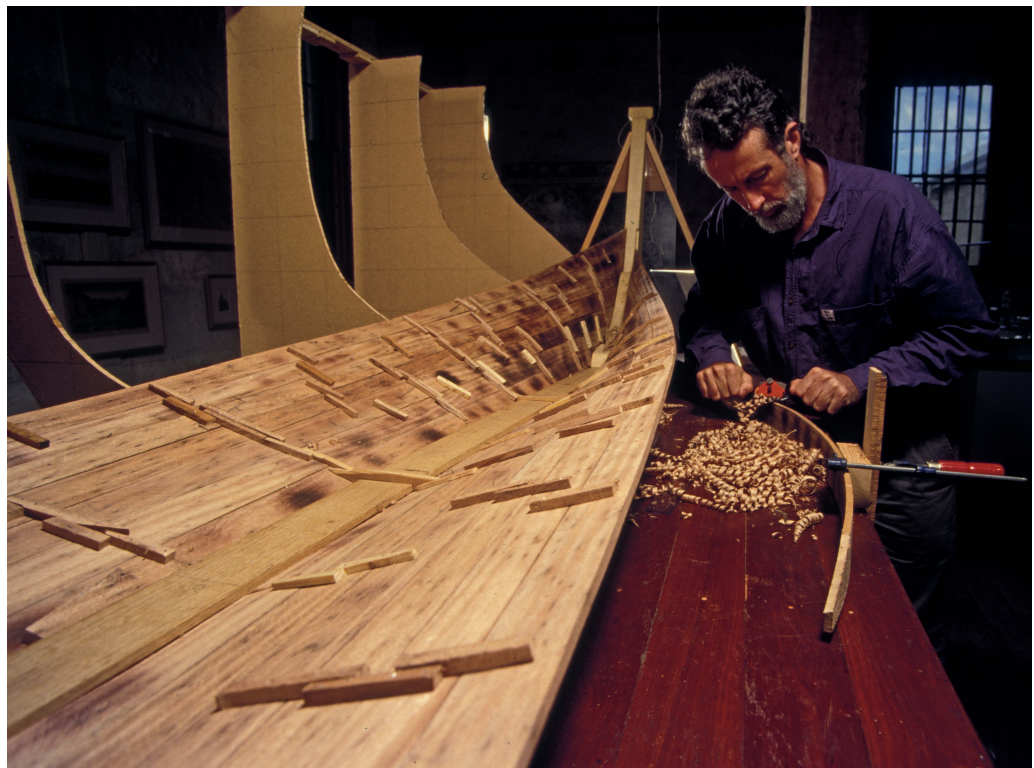
FIGURE 3-21.
Nick Burningham
working on 1:10 scale
model of the *Batavia*
ship. Photograph by
Patrick Baker, Western
Australian Museum
(BT-M-0031).

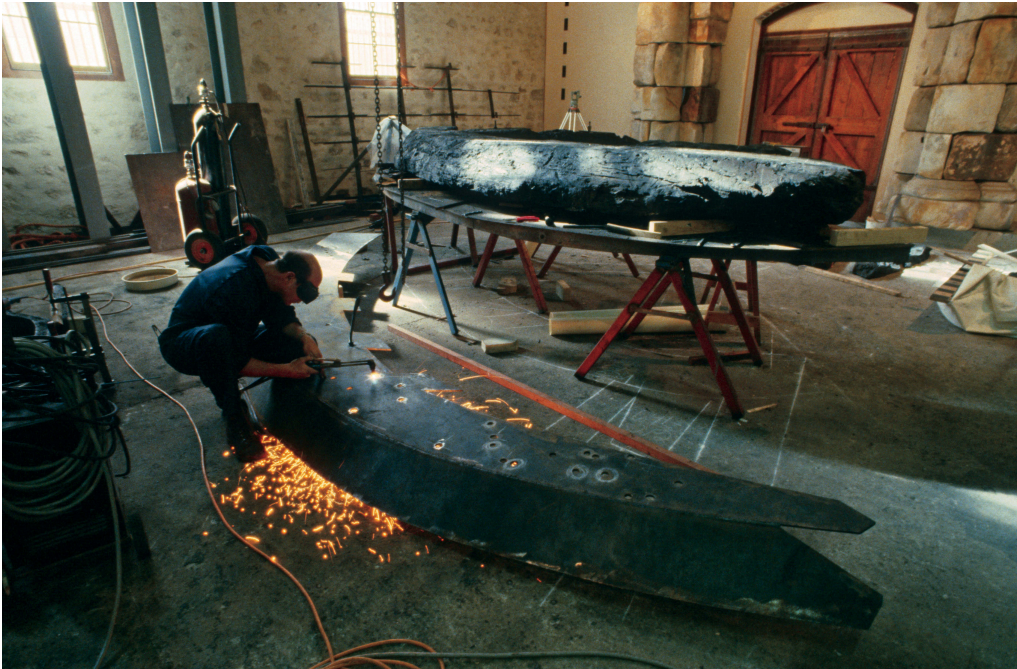
FIGURE 3-22.
Geoff Kimpton
constructing the
steel backing plate
for *Batavia*'s fashion
piece. Photograph by
Brian Richards, Western
Australian Museum
(BT-T-0223).

In May 1981, the conservation of the fashion piece was completed. After the timber was moved from the dehumidification area into the gallery, a full-size drawing was made and subsequently used for the fabrication of a 1 cm thick steel outline of the timber (fig. 3-22). This template served as a backing plate to support the timber on display and as the outline of the framework for the transom.³⁰ The timber was laid on the plate and bolted to crosspieces on its opposite surface, which functioned as a splint. The encased fashion piece formed the base of the transom reassembly, which was built up from this template (fig. 3-23). It also delineates the outer shape of the transom.

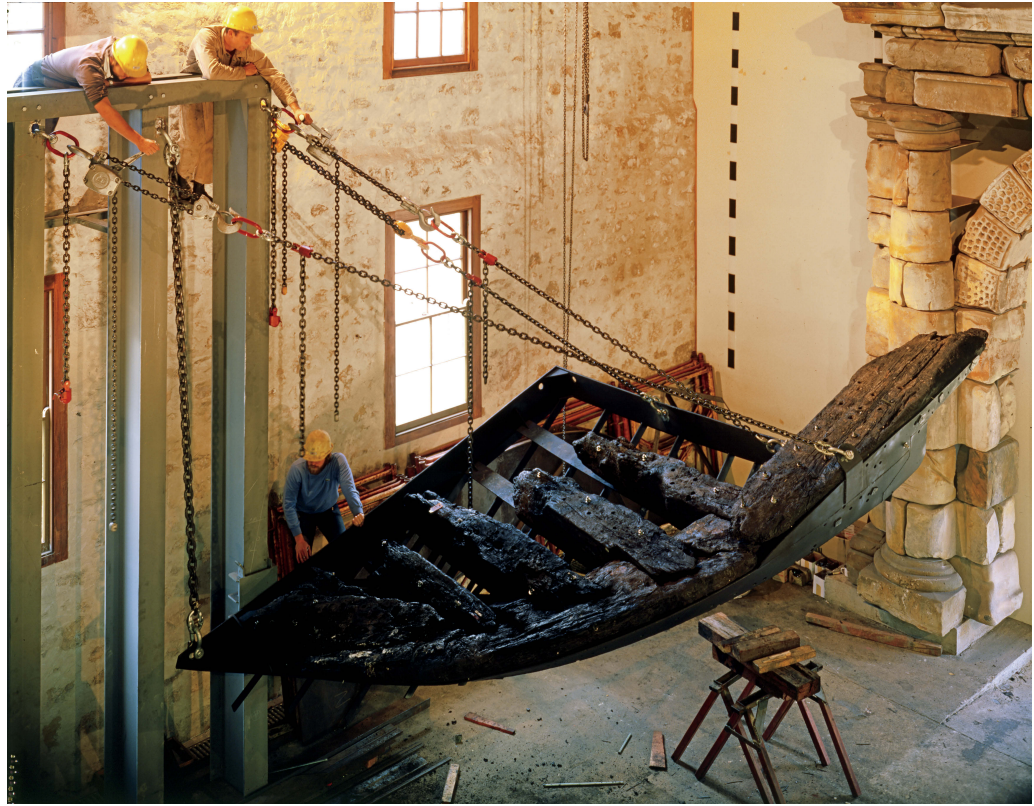
FIGURE 3-23. Raising the steel framework to support the transom timbers in place in the Western Australian Museum—Shipwreck Galleries, Fremantle. Photograph by Brian Richards, Western Australian Museum (BT-T-0046).

The framework itself is supported by five Royal Steel Industry (RSI) steel pillars, four forming a square encased set and a fifth one placed away from this assembly, that are fixed into concrete supports in the floor and bolted against the wall of the *Batavia* gallery (see fig. 3-23). These load-bearing pillars carry the heavy weight of the display by seating the timber in an open framework that resembles a drawing of a ship's lines. Kimpton designed the framework in such a manner that the timbers can be taken off if necessary for

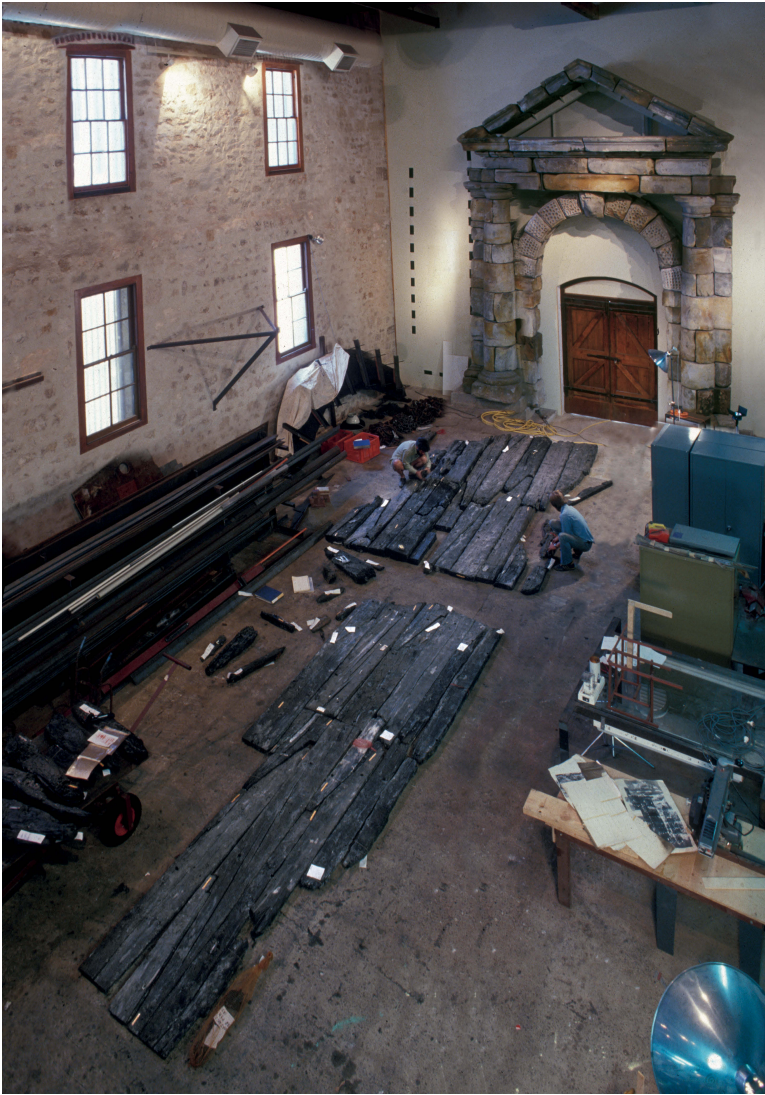
FIGURE 3-24.
Sorting *Batavia*
hull planking after
conservation in the
Western Australian
Museum—Shipwreck
Galleries, Fremantle.
Photograph by Patrick
Baker, Western
Australian Museum
(BT-T-0155).

In December 1981, the first of 15 batches of timbers had undergone conservation treatment. The timbers were laid out on the floor of the gallery and rearranged in their position as found on the seabed as if part of a giant jigsaw puzzle (fig. 3-24). The timber plans from the first two excavation seasons and the photomosaics facilitated this process. This process was started over every six months when the next batch of timber came out of conservation.

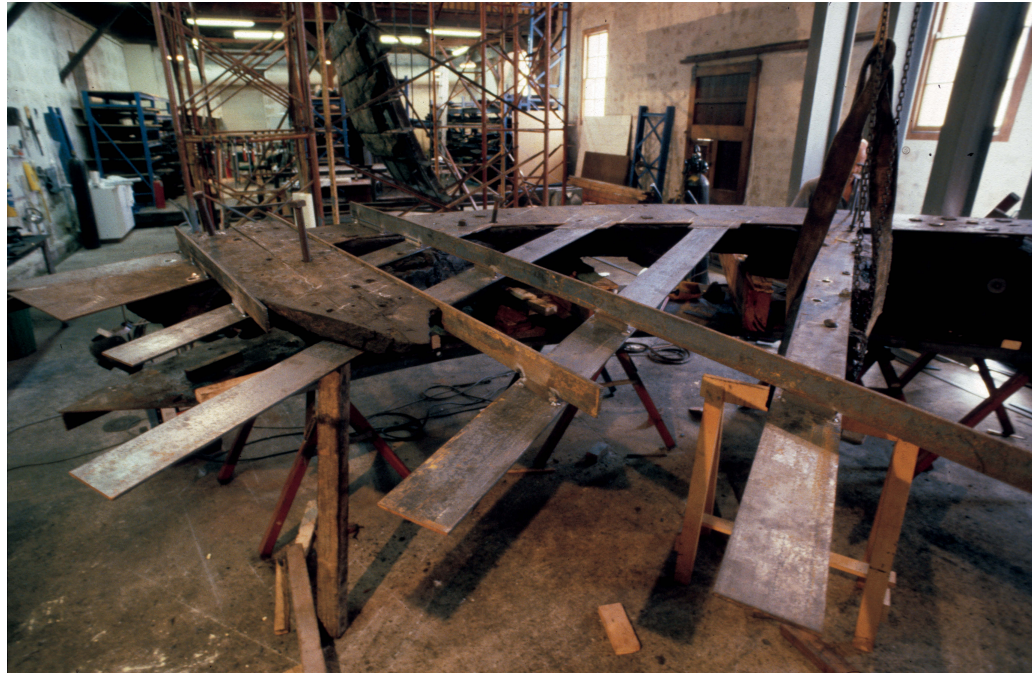
FIGURE 3-25.
Constructing the steel support for the transom planking on the backing plate of the fashion piece and transom beams, Western Australian Museum—Shipwreck Galleries, Fremantle. Photograph by Brian Richards, Western Australian Museum (BT-T-0239).

After the steel supports of the fashion piece and its futtock were finalized, the transoms were placed in their seatings on the fashion piece and a custom-made support of steel was added to the steel backing for the fashion piece. The bolt holes of the diagonal transom planks were used to fit the transom timbers in their proper place. At this stage the bolt holes of the transom knees were also lined up with the beams and transom planking to prevent assembly problems later on. For the transom planking, steel strips 12 mm thick were welded diagonally to the steel frame in between each transom plank (fig. 3-25). After the framework of the transom was completed, it was lifted in place by using pulleys on the steel pillars alongside the gallery wall (see fig. 3-23). The lower end of the transom framework was attached to a 50-ton, load-bearing, high-tensile bolt on the side of the pillars, which enabled the transom to be lifted into position and altered as the structure

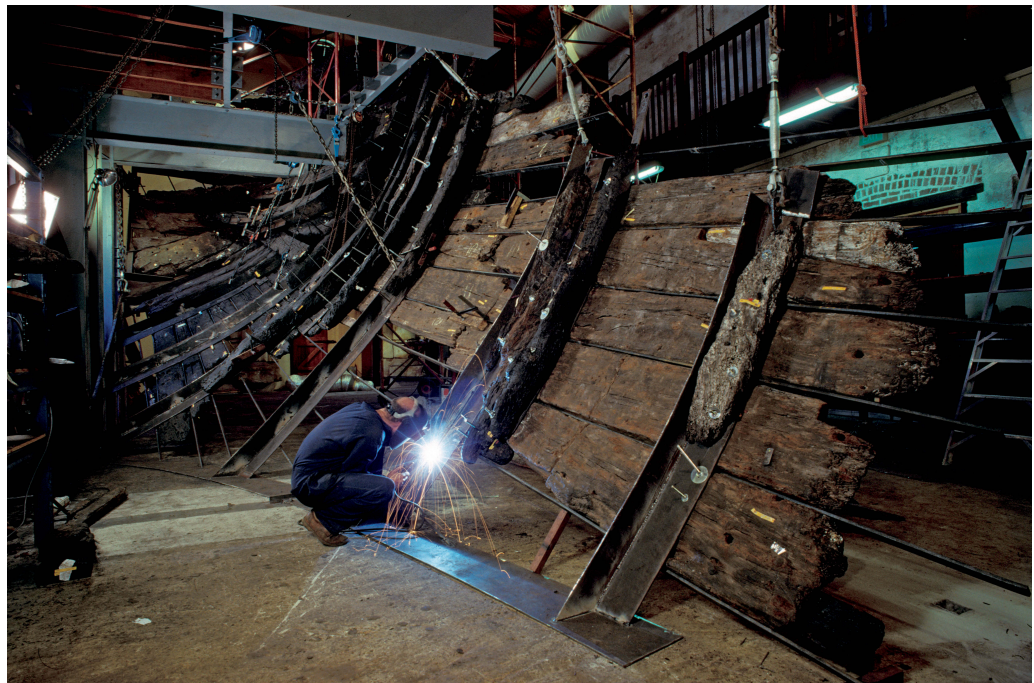
FIGURE 3-26.
Geoff Kimpton welding the backing plate of the frame to steel battens that support the hull planking, Western Australian Museum—Shipwreck Galleries, Fremantle. Photograph by Patrick Baker, Western Australian Museum (BT-T-0404).

The framework for the side of the ship is constructed on steel strips that support the timbers. A number of frames were selected, for which backing plates were made. These plates form the stationary lines of the framework that are welded to a steel band that runs over the museum gallery floor as a curved pathway (fig. 3-26). Initially, steel cables tightened to temporary crossbeams that extended from the load-bearing pillars alongside the wall held them upright. The crossbeams and cables were eventually replaced by steel rods.

The planks are placed in between flat strips of steel that run along the side of the hull like battens (varying between 2.5 and 5 cm in width and 10 and 12 mm in thickness). These steel battens are seated between each layer of planking and welded to the vertical backing plates of the frames. This assembly takes the main load off the planks. In between the two layers of hull planking, vertical strips run from one batten to another to keep the inner layer of hull planking from leaning against the outer layer. The vertical strips are screwed, not welded, to the edges of the steel battens so they can be removed if a timber

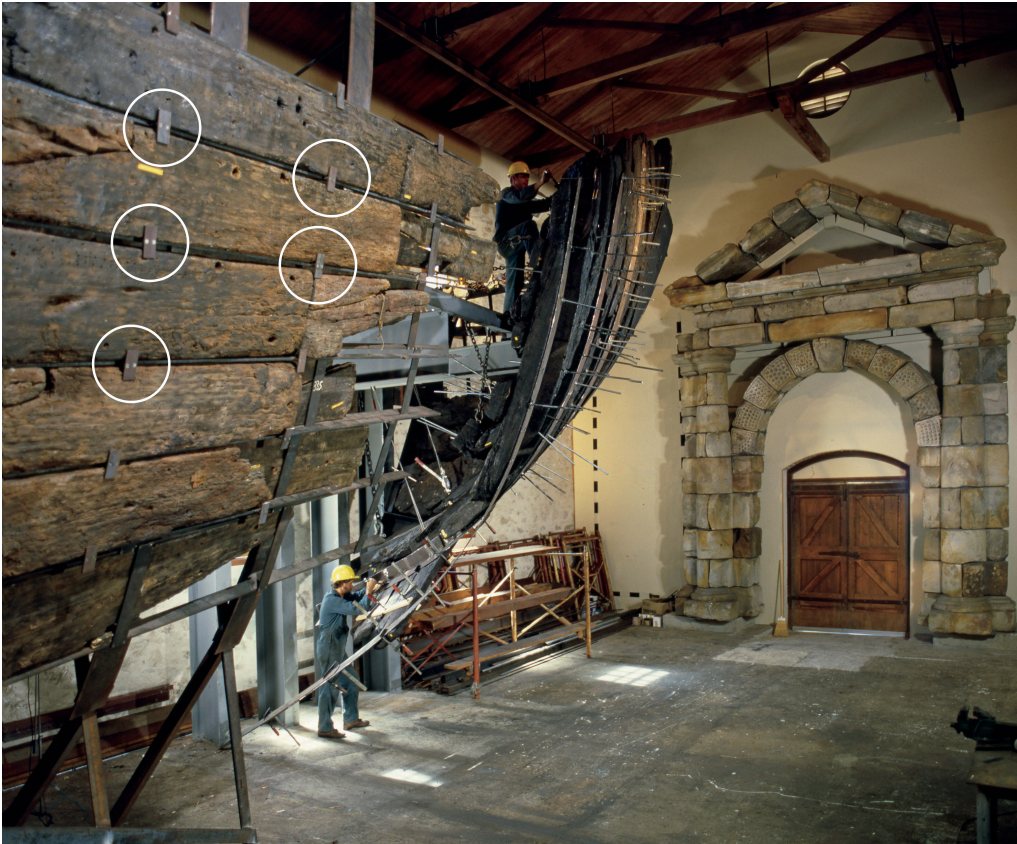
FIGURE 3-27. Vertical strips and stoppers (circles) preventing the hull planks from falling out of the framework, Western Australian Museum—Shipwreck Galleries, Fremantle. Photograph by Patrick Baker, Western Australian Museum (BT-T-0377).

needs to be taken off the display (fig. 3-27). Initially, small vertical lips were added to the edges of the battens (one on top and one on the bottom) to prevent the outer layer of hull planking from falling out. Most of them have been removed, as the 16.75 mm threaded galvanized rods, used in the reassembly to fasten the frames to the hull planking, provided sufficient strength for keeping the outer layer of hull planking in place. The galvanized rods were inserted into selected original bolt holes (fig. 3-28). They were used
